SPACE LAUNCH SYSTEM

Developing the World's Most
Powerful Solid Rocket Booster

Alex Priskos
May 5, 2016

Space Propulsion Conference

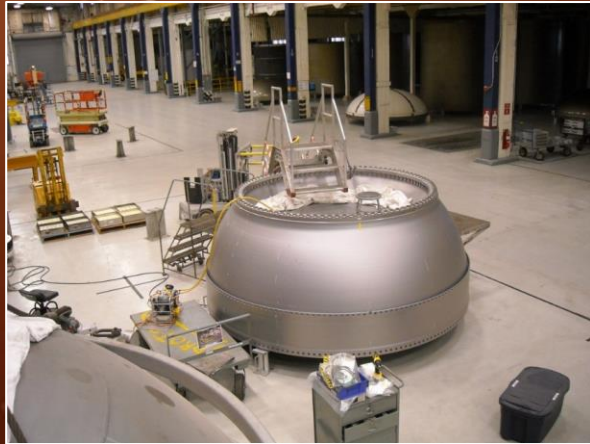
EM-1 motor case
hardware refurbishment

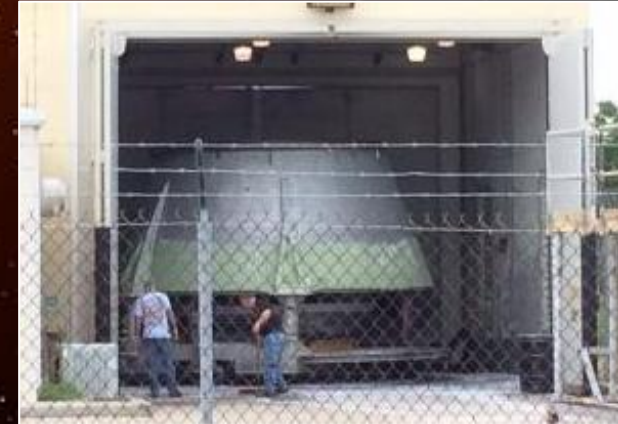
EM-1 LH aft skirt refurbishment

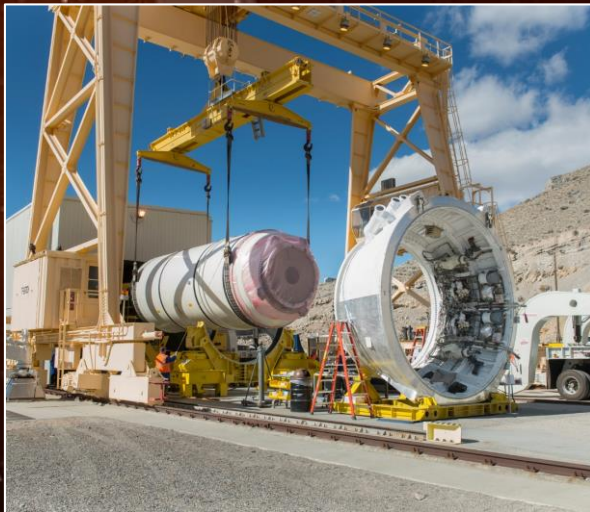
QM-2 aft segment
delivery to test stand

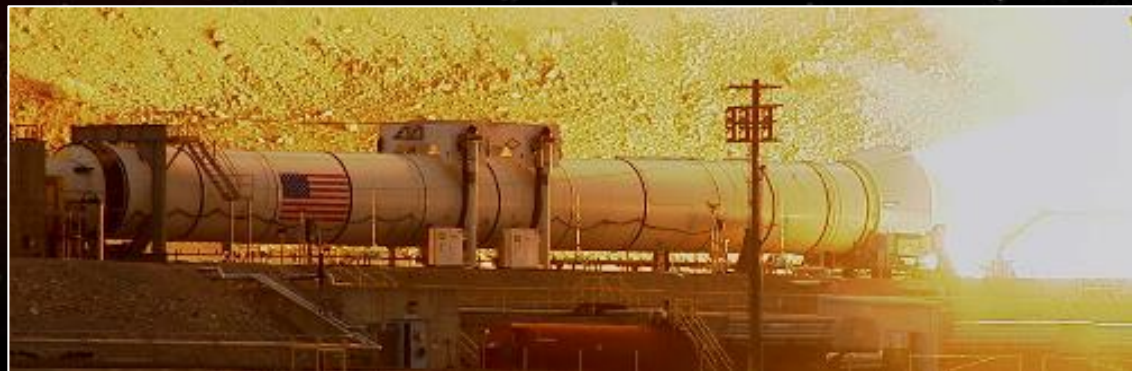
QM-1 static test

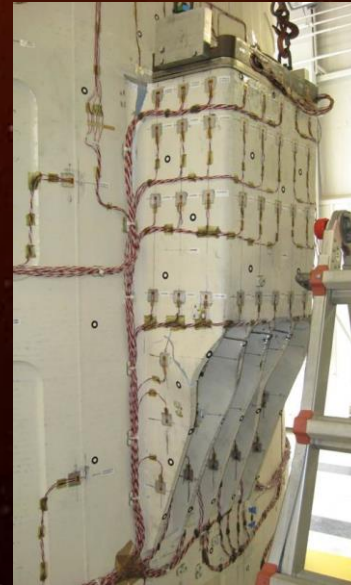
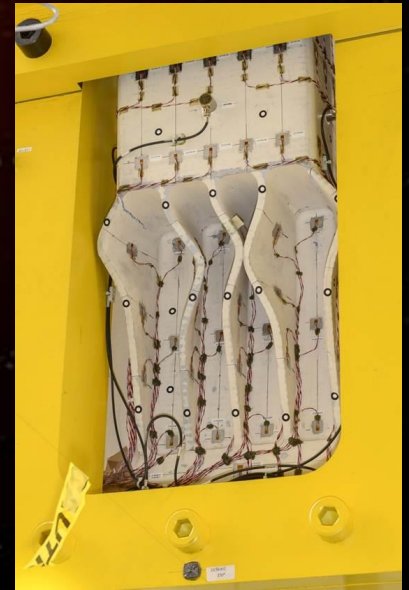
Challenges – Forward Skirt

- Predicted SLS loads at the forward thrust post were increased over what was seen during the SSP.

- Two forward skirt structural test articles were tested to failure (liftoff and ascent loads).

- Both tests determined the failure point was beyond required capability.
- Testing and analysis showed that the heritage forward skirt design can be used for SLS, eliminating the need for a redesign.

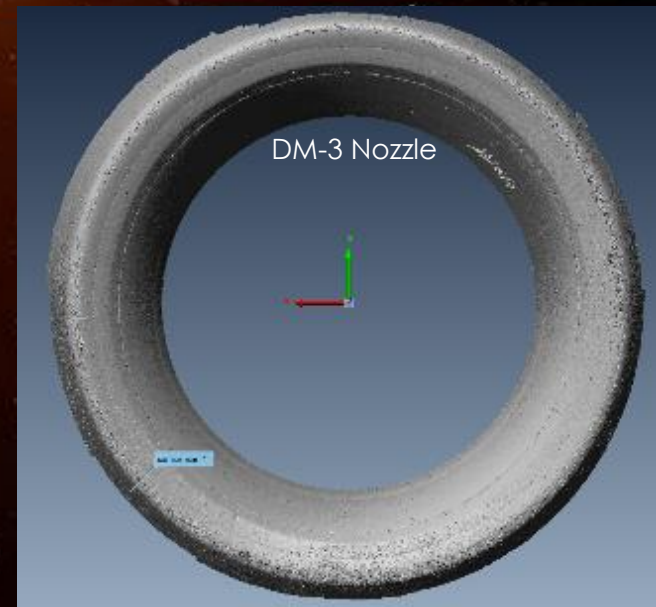
Challenges – Abnormal Nozzle Erosion

- DM-2 and DM-3 FNR experienced abnormal erosion at the bottom of the nozzle

- Instrumented DM-3 with ultrasonic gauges, capturing the timing and magnitude of erosion
- TVC duty cycle and slag were not contributors to abnormal erosion; particle impingement and environments found to be the contributors

- FNR ply angle change
- FNR material change
- Additional mid-span support to reduce sag during static test
